October 12, 2020

Version 3

2018-21 Odyssey: Popping or Crackling from the Speakers; No Sound from the Audio System; *Network Loss Message and/or Display Issues*

Supersedes 20-049, dated July 27, 2020, to revise the information highlighted in **yellow**.

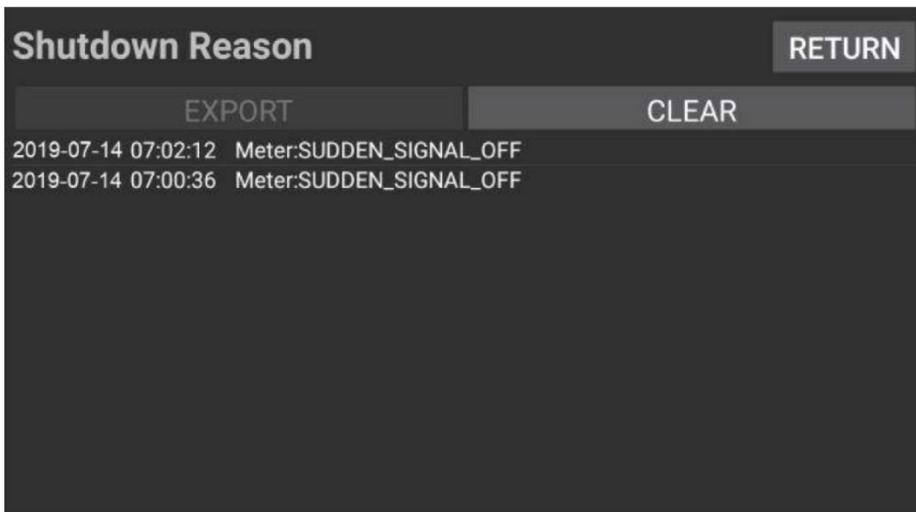
In this example, the cause of the failure can be identified as **Meter:SUDDEN_SIGNAL_OFF**.

Write down any failures; they will be collected on the warranty claim. Then, clear the data.

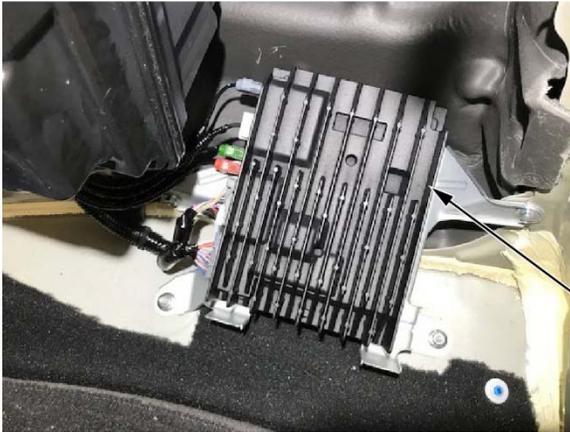
STEREO AMPLIFIER OR
TUNER-AMPLIFIER

There is a loose connection in the MOST bus network.

25. Disconnect the red and green FAKRA connectors from the stereo amplifier (Elite) or tuner-amplifier unit (EX, EX-L, Touring), gauge control module, and infotainment unit using the straight FAKRA puller.
